Manhole Inspection Summary

Manhole # S37UU_011MH

Insp Date: **12/20/06 10:17 AM**

Location Address: **429 ILCHESTER AVE**

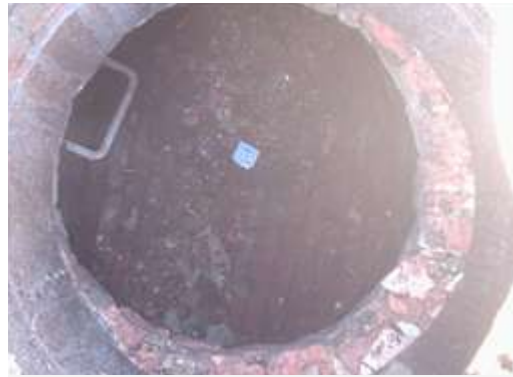
Top View

Channel debris.

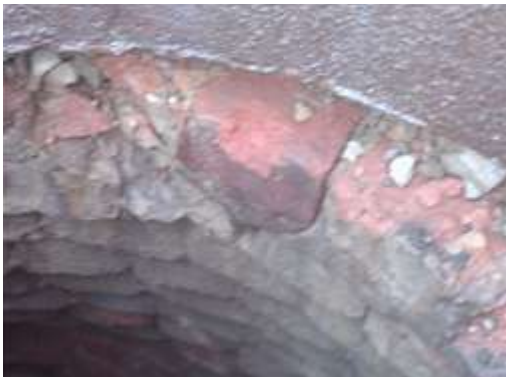
Defect

Frame leaks. Frame offset. Adjustment deterioration, loose brick and infiltration. Barrel infiltration.

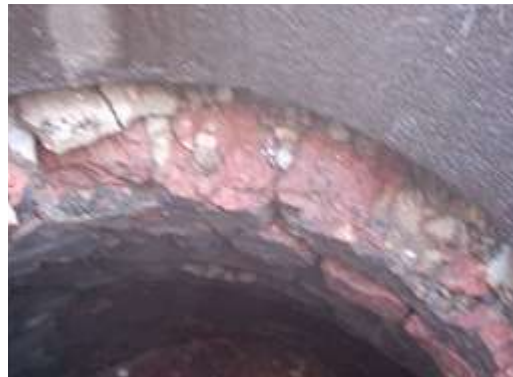
Defect

Frame leaks. Frame offset. Adjustment deterioration, loose brick and infiltration. Barrel infiltration.

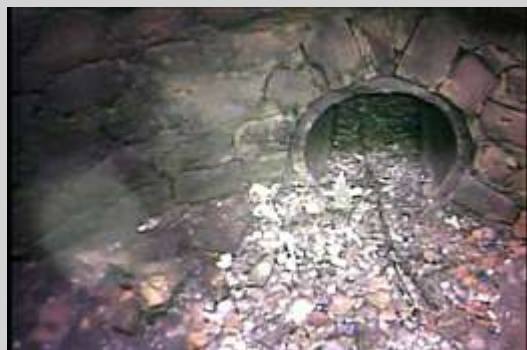
Pipe Out @ 12 O'Clock

Barrel deterioration and infiltration.
